Guided Wave Inspection Report

Demo Report

GWT-001-REP

Eddyfi Technologies

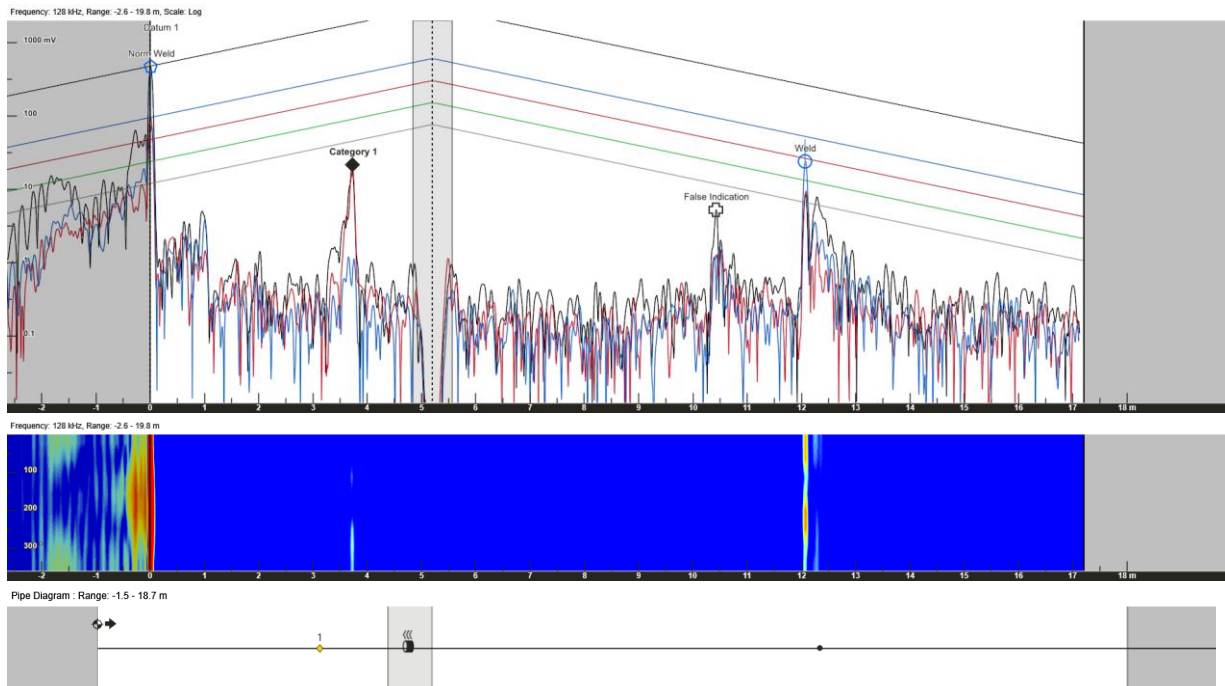
4in pipe loop, Datum 1, 128kHz CUPS

This is a short range scan using the Sonyks 128kHz Magnetostrictive tooling. It shows a close up of the CUPS defect at the pipe support taken as the defect was grown. Note that even though this defect is small (1.2% CSC) there is still 27dB SNR.

Position	Indication Details	Position	Indication Details
0.0 m	□ Pipe End	5.6 m	↓ Dead zone (Start)
3.7 m	◆ Category 1 Response Intensity: High CSC: 1.2 % (@ 128 kHz)	10.4 m	⊕ False Indication - Mirror signal from Flange
4.8 m	↑ Dead zone (End)	12.1 m	○ Weld
5.2 m	● Tool

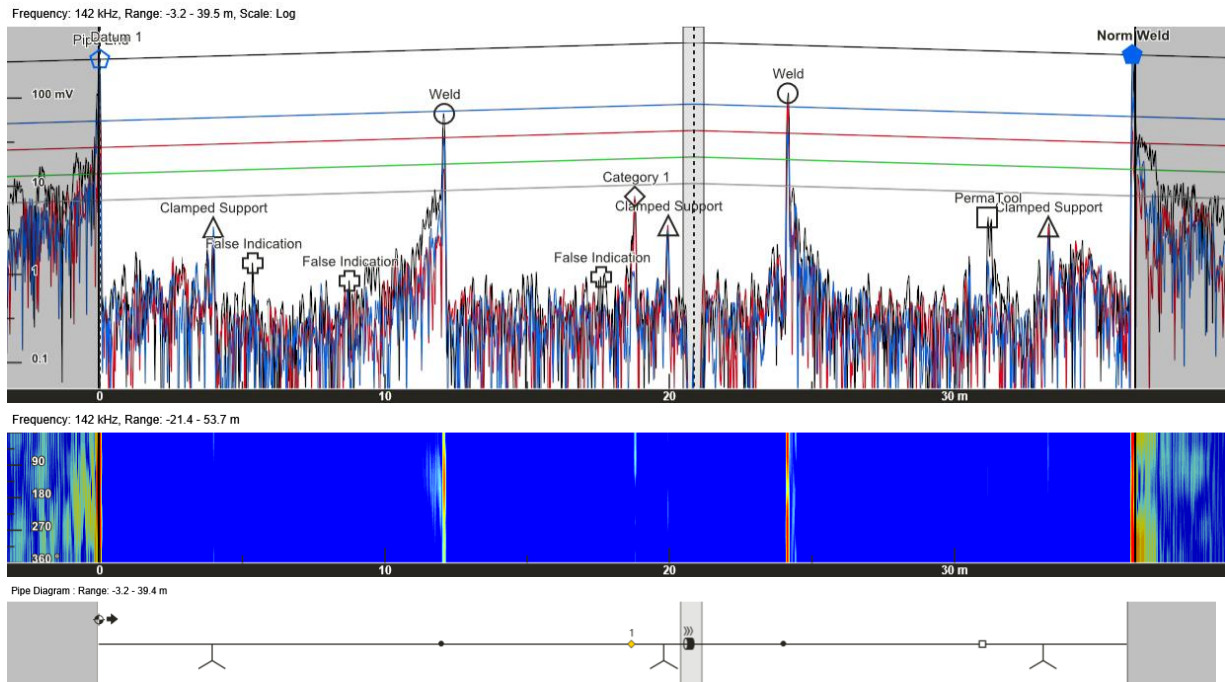
4in pipe loop, Datum 1, 128kHz No CUPS

This data was collected with the Sonyks 128kHz Magnetostrictive tooling. It shows the full length of the pipeline was acquired from one test location. This data was acquired before the CUPS defect was put in place. Note the similar response from all pipe supports.

Position	Indication Details	Position	Indication Details
0.0 m	□ Pipe End	18.8 m	◆ Category 1 CSC: 1.9 % (@ 142 kHz)
4.0 m	⤴ Clamped Support	19.9 m	⤴ Clamped Support
5.4 m	⬛ False Indication - Mirror from pipe end	20.5 m	⬇ Dead zone (Start)
8.7 m	⬛ False Indication - Repeat from weld	20.8 m	🔧 Tool
12.1 m	○ Weld	21.2 m	⬆ Dead zone (End)
17.5 m	⬛ False Indication - Mirror from Weld	24.1 m	○ Weld
		31.1 m	□ PermaTool - Bonded Magneto strip

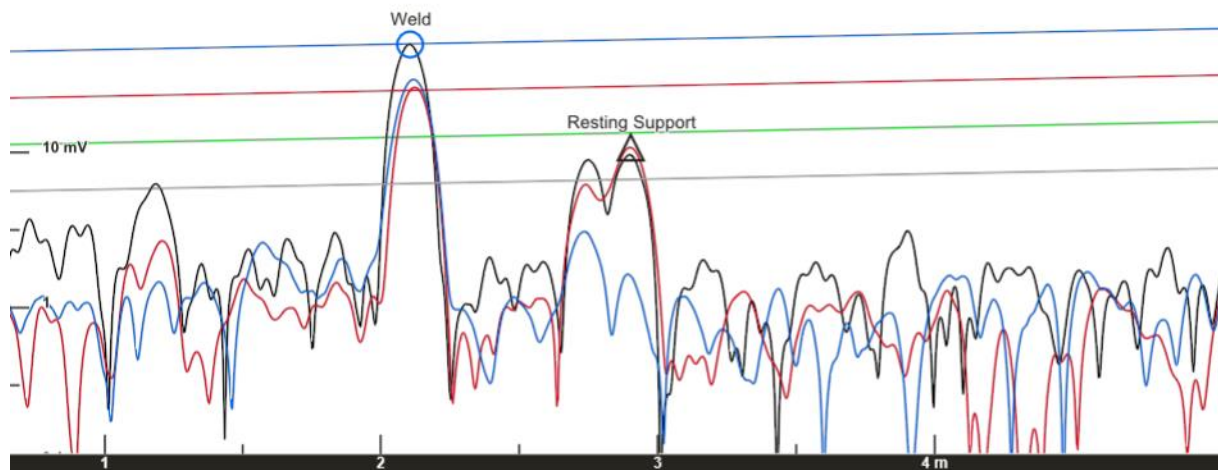
A-scan

Frequency: 66 kHz, Range: 0.7 - 5.1 m, Scale: Log

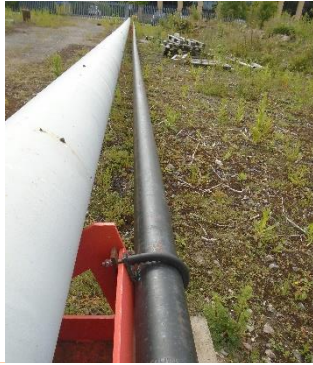
Image 1
4in pipe loop – West End
Showing clamped support with cups.

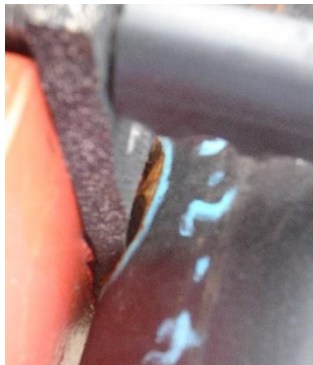
Image 2
4in pipe loop – West End
Picture of cups at support.

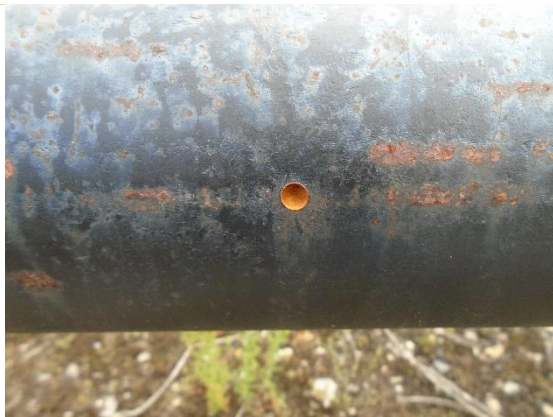
Image 3
4in pipe loop – Central
Category 1 anomalous indication.

Quantitative inspections such as Radiography or Conventional UT are recommended on all classifications of anomalies.

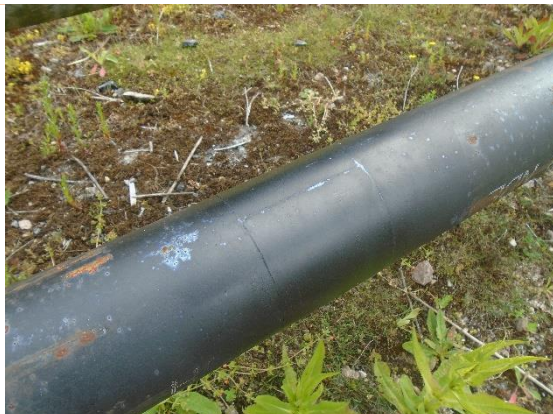
Image 4
4in pipe loop – East End
PermaTool - Bonded Magneto strip
